## Forest Health Protection Pacific Southwest Region

Date: September 20, 2013

Subject: Chilcoot Campground Hazard Tree Evaluation (FHP Report NE13-07)

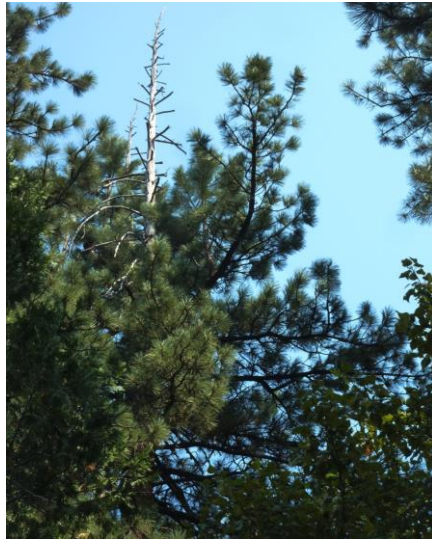
At least two large JP with defects were discussed. One of these had two dead tops (Figure 1) and the other had a swollen crook and was leaning towards a much-used stretch of Little Last Chance Creek (Figure 2). The latter is planned to be felled. Because dead pine tops are usually not decayed, the dead topped pine is of lesser concern; but it would be safest to remove the dead tops by a professional tree service. Except for the presence of dead branches in the lower crowns of a number of large JP trees (Figures 3 and 4), most conifers in the campground appeared sound. The number of JP trees needing branch pruning in each campsite were noted on the campground map. No sign of root disease was found in the conifers; however root disease and decay is generally hidden underground and impossible to detect without an accompanying decline in the

Figure 1. JP with dead tops.

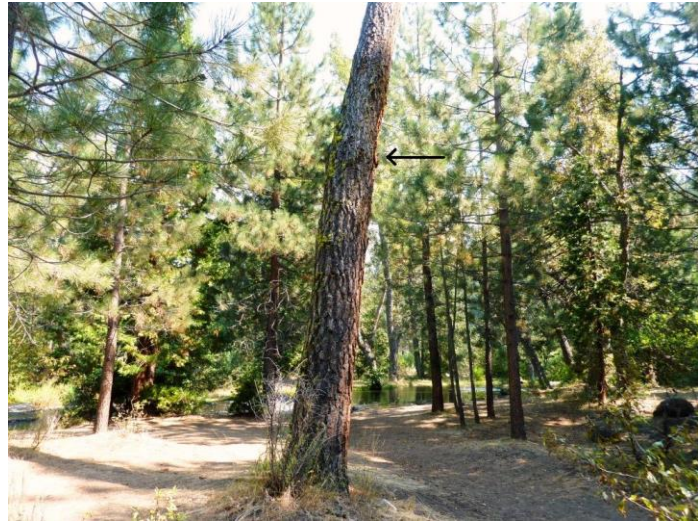
Figure 2. JP leaning towards creek (arrow points to swollen crook)

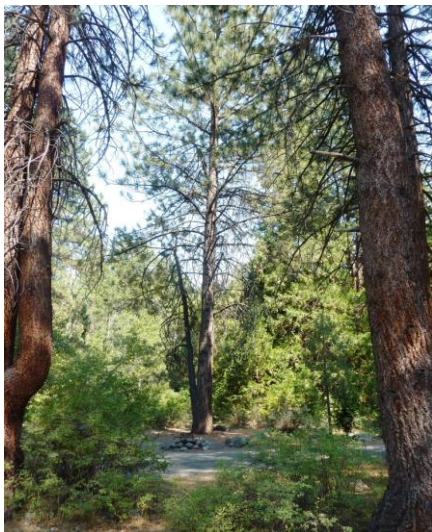
Figure 3. IP with overhead dead branches

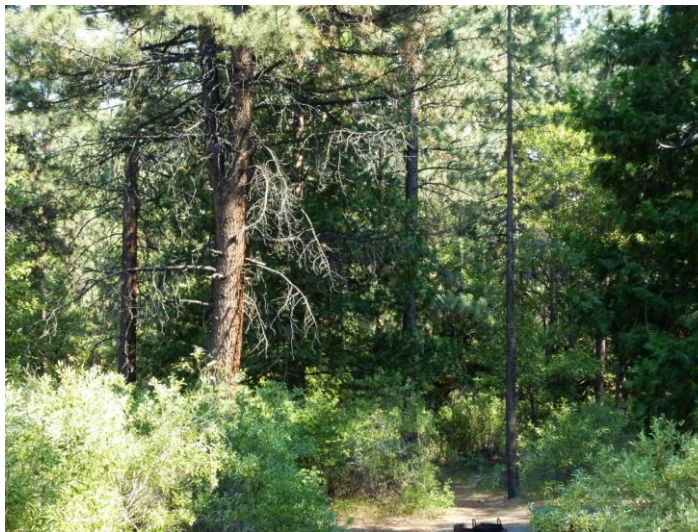
Figure 4. IP with overhead dead branches

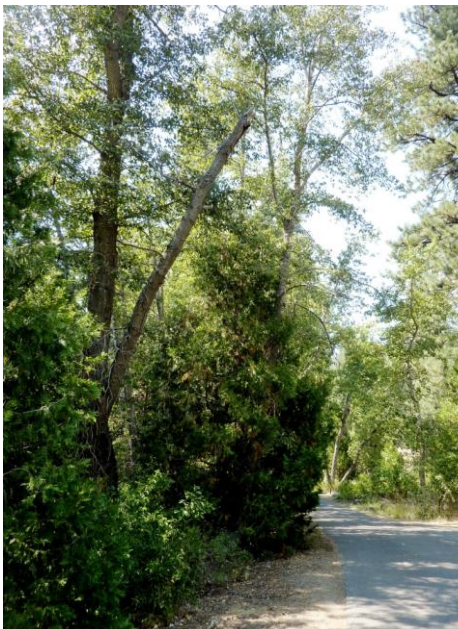
Figure 5. Dead CW tree leaning over road.

which can detect decay in wood). When serious decay was measured with the Resistograph in a CW tree with visible butt rot, the tree was identified for removal on the campground map. In addition to CW trees with serious butt rot, dead CW trees (Figure 5) were identified on the map for removal. Campsites with high risk hazard trees which cannot be removed or mitigated immediately were closed. Chilcoot CG was close for the season just after Labor Day. The campground concessionaire will hire a professional tree service to remove or prune the identified hazard trees before the campground opens in 2014. It is recommended that the Forest Service collaborate with the concessionaire and the tree service to determine the safety of CW trees with visible or suspected defects. Prior to opening this (and all) campgrounds, managers should resurvey for new tree hazards and to reevaluate “monitor trees”.

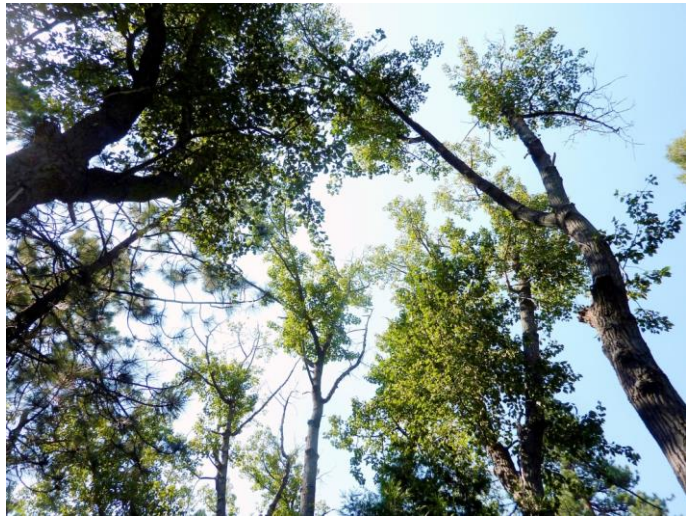
Campsites 13 and 14 had six or more large cottonwoods (Figure 6) with declining crowns and dead branches, each within striking distance of several targets. These CW trees appeared to have sound butts; however some appeared to have decay in the upper boles. The lack of foliage in the crowns of these trees suggests that advanced decay may be present in the roots and/or boles of these trees. Without expert inspection by a licensed professional, the stability of these trees is uncertain. Campsites 13 and 14 were promptly closed for the season.

**Figure 6. Declining CW trees in Campsites 13 and 14.**

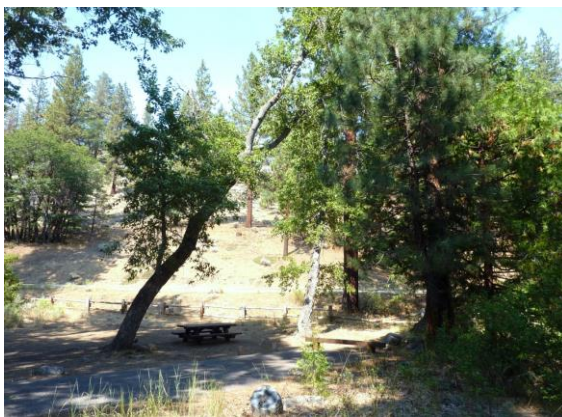
A campsite adjacent to the highway and east of campsite #14 has two large CW trees with excessive lean (Figures 7 and 8). Both trees are leaning over potential tent sites. Both trees were drilled with the Resistograph. The CW nearest the highway (Figure 7) had exposed and damaged roots and excessive decay in the butt and was designated on the map for removal. The other CW (Figure 8) appears sound; but its excessive lean is cause for concern. If retained, campers should be instructed on the danger associated with camping under this tree. Preferably, the impact area under this CW would be fenced or otherwise designated as a “no camping area”.

**Figure 7. CW with decaying butt and damaged roots leaning over tent site..**

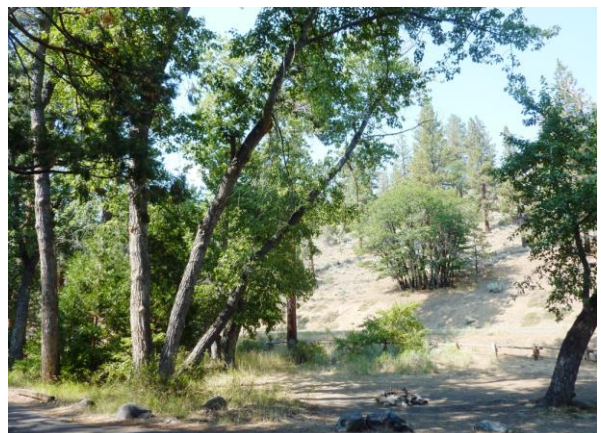
**Figure 8. CW with much lean growing over a camping area.**

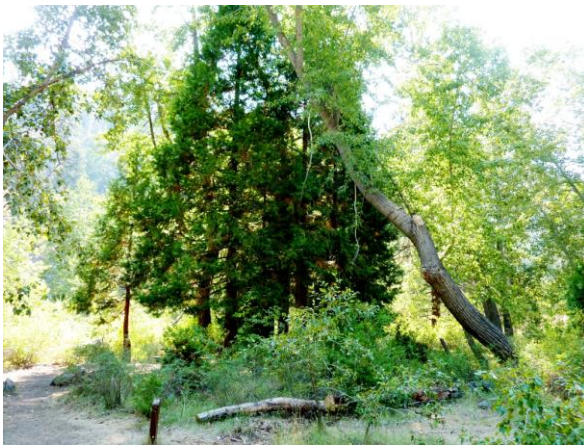
On August 13, Woodruff used a ladder to access decay ten feet above ground in a large CW tree (Figure 9) in the northernmost campsite in Chilcoat CG. The entire tree is growing with a pronounced lean over the campsite. The lean is significant yet it appears to have begun a very long time ago. The tree was checked with the Resistograph near the ground on July 31 and no significant decay was detected. However on August 13 significant decay was found at a large severed branch (Figure 10) ten feet above ground. This decay seems to be limited to less than 25% of the cross section; but since a large and heavy portion of the bole above this defect is growing at a significant angle over the campsite, there is cause for concern. A second severed branch higher up the bole appears to also be decaying. Further investigation by a licensed professional tree service is recommended. This tree does not appear to be an imminent danger to visitors, but until this tree is examined by a licensed tree inspector, this conclusion is questionable. At a minimum, this tree should be carefully monitored to promptly identify changes in tree vigor; or signs that the various bole decays have become excessive.

Figure 9 CW with decay in bole growing over campsite.

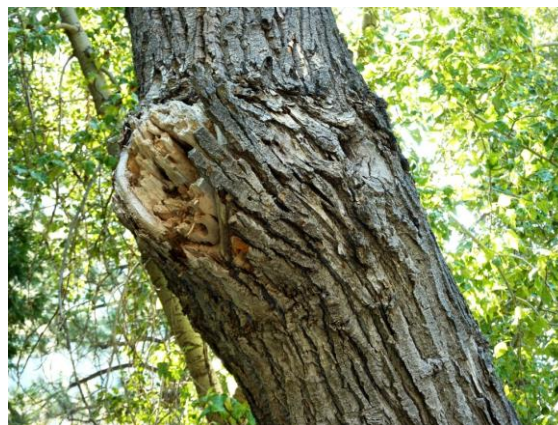
Figure 10. Decay in CW bole at a severed branch.

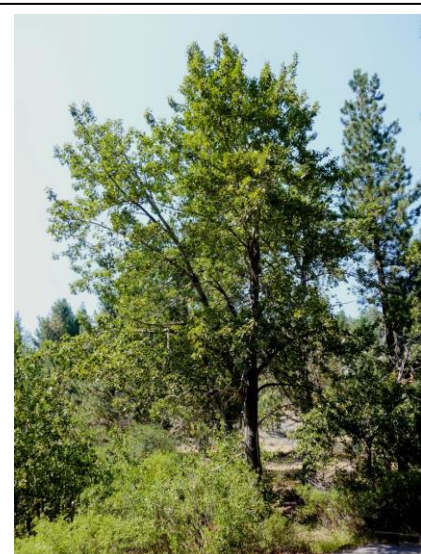
Figure 11. Healthy-looking CW tree.

Although not previously discussed, soil compaction around campgrounds trees should be minimized. Soil compaction can stress trees and make them vulnerable to insect attack and decay. Healthy CW trees (Figure 11) in Chilcoat CG (as well as conifers) should be protected from soil compaction and damage to the bole which could allow decay organisms to infect the wood. Removing overstory trees and limiting soil compaction can enhance the growth and reproduction of CW trees in Chilcoat CG.
